Spacecraft Redesign to Reduce Microphonic Response of a VCO Component

ABSTRACT

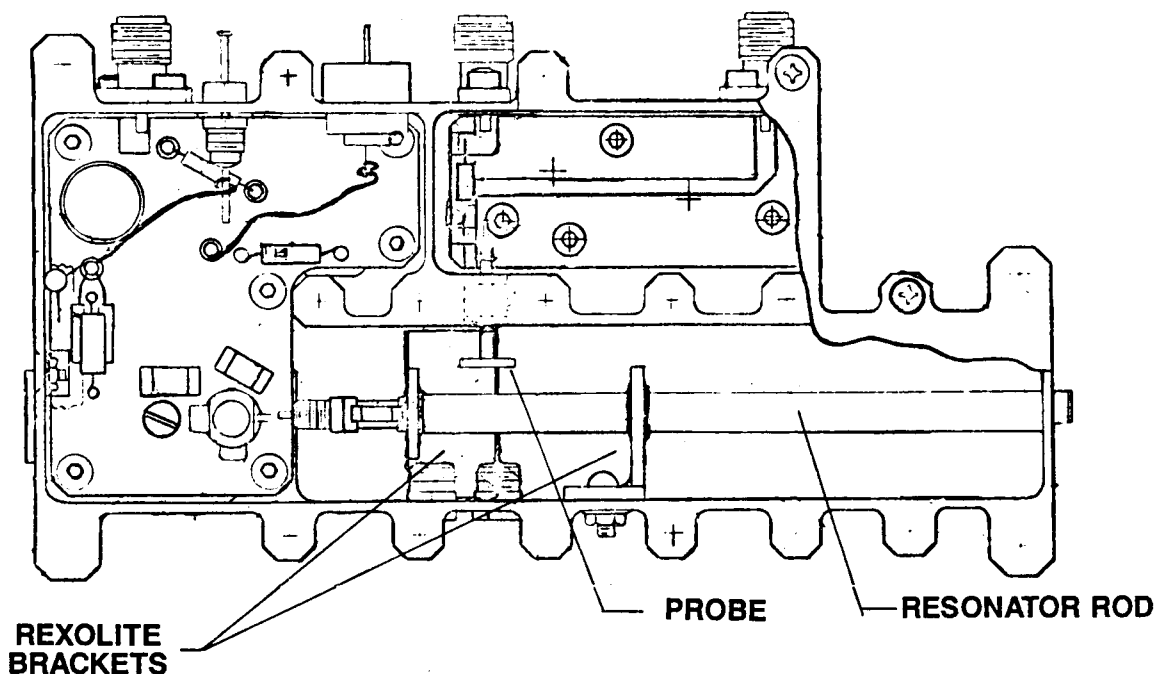
Figure 2. VCO Assembly (Top View)

The VCO assembly is shown in Figure 2. The outer box consists of machined aluminum sides and a separator wall running through the middle of the box. The box has an aluminum top cover attached by means of five screws. The figure shows the box with the top cover partially removed to reveal details. The resonator rod is located in the lower right cavity. It is a hollow rod supported on two L-shaped rexolite brackets. The left bracket is glued to the bottom of the box whereas the middle bracket is attached to the outer side with two screws. The right end of the rod is screwed to the outer wall. The left end of the rod is attached to a strap spring. A probe extends from the middle wall in between the two brackets.

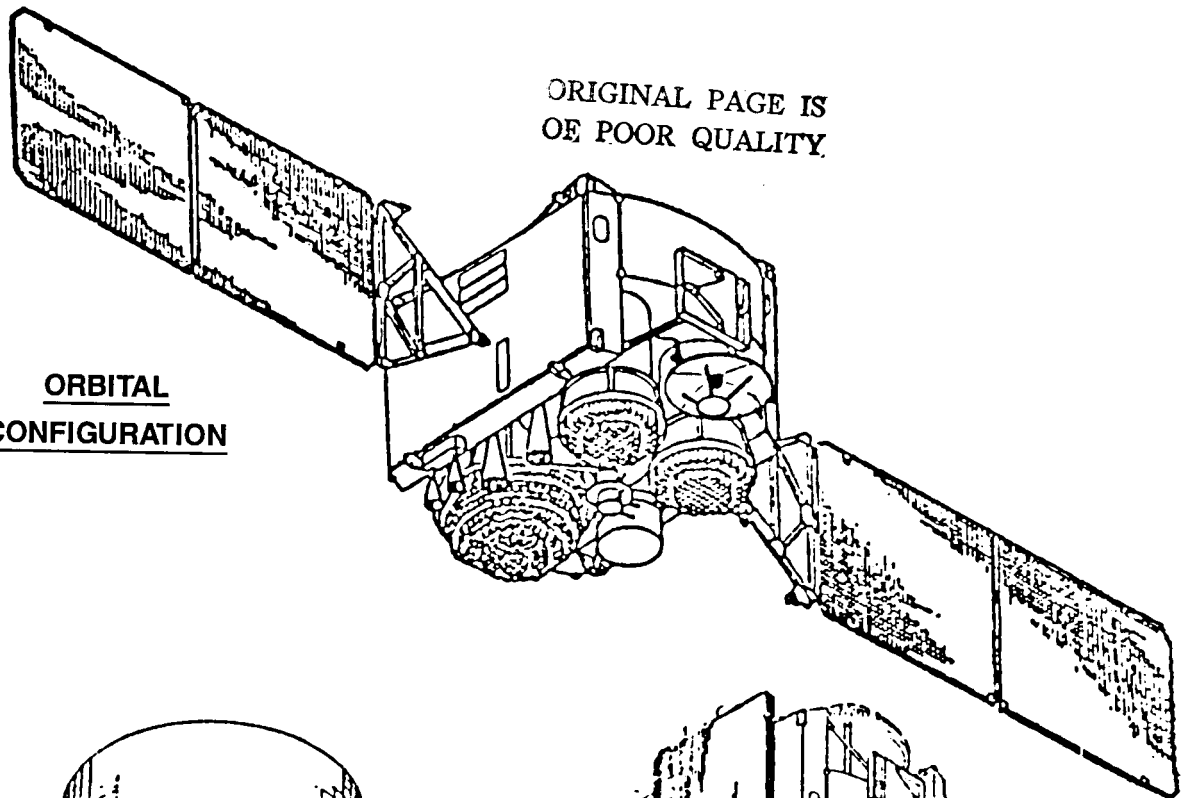
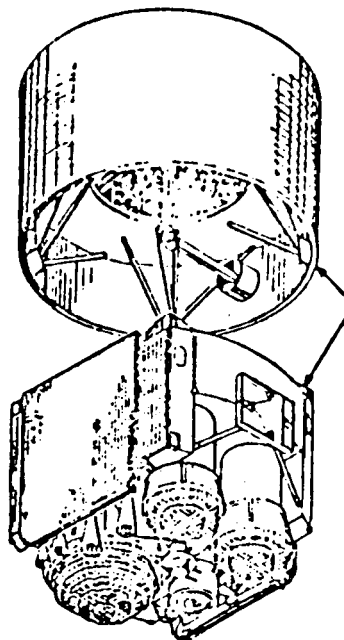
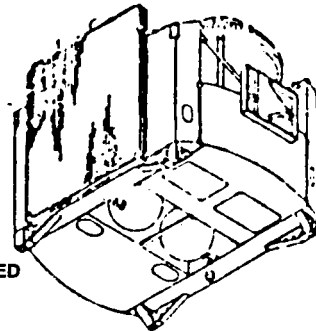
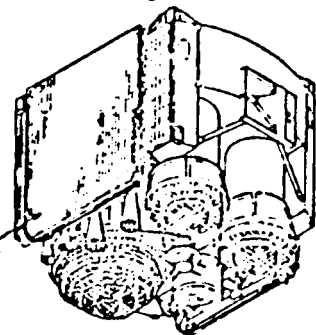
Figure 1. DSCS III Spacecraft Configurations

The DSCS III satellite is designed to be placed into a low inclination geosynchronous orbit on either the Titan 34D/IUS, Titan 34D/Transtage or Shuttle/IUS launch systems. The satellite can be configured for a dual launch with either a DSCS III satellite or another DSCS III in a tandem launch mode, as shown in Figure 1. Also shown in this figure is the satellite in its orbital configuration. On orbit stabilization is about all three axes with four Attitude Control System reaction wheels.

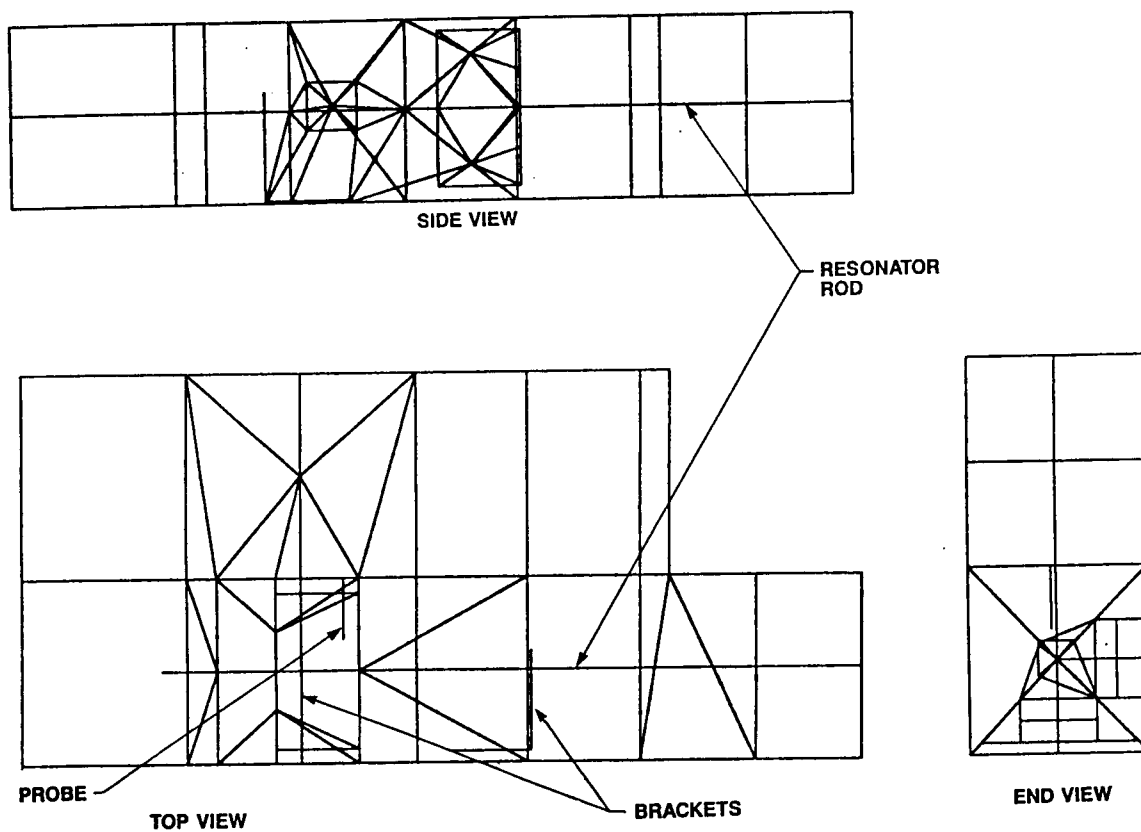
Figure 3. VCO Assembly Finite Element Model

A detailed NASTRAN finite element model of the VCO assembly was made with the SUPERTAB/IDEAS system. The analysis was performed on the IBM 3090 system with the MSC/NASTRAN finite element program. The model is shown in Figure 3. Special care was taken to model the resonator rod stiffness and inertia distribution and its attachment to the VCO outer box. Rexolite brackets were modelled in detail to provide for variable fixity, to and offsets from the box center lines. The model consisted of 254 structural elements, 153 nodes and 175 dynamic degrees-of-freedom. A number of simpler component models were analyzed to trace the source of the 1600 Hz amplification. These included the probe model, the strap spring model, plate models to represent VCO outer box sides, and the resonator rod on its bracket model extracted from the overall assembly model. Of these component models, only the resonator rod model provided a clue to the sideband problem. It revealed that the rod resonant frequencies are very sensitive to the bracket fixity. The natural frequency varied from 1458 Hz to 2291 Hz for the first bending mode in the lateral plane and from 2036 Hz to 3289 Hz for the first bending mode in the vertical plane depending on the bracket attachment conditions. The rexolite brackets themselves, as originally designed, appeared to be very flexible.

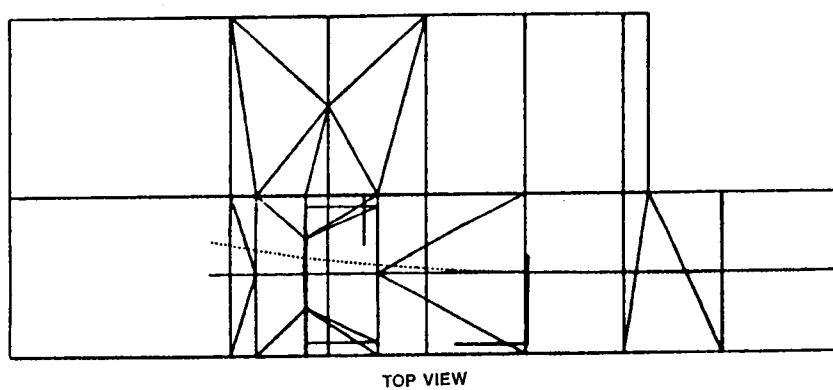
Figure 4. VCO First Mode (Beam-Lateral at 1949 Hz)

The eigenvalue analysis performed on the VCO assembly showed that there are no natural frequencies below 1500 Hz. The first two modes calculated are shown in Figures 4 and 5, where the dotted lines represent the deflected shape superimposed on the undeformed configuration shown by the solid lines. The natural frequencies were found to be 1949 Hz and 2618 Hz for the two beam bending modes. This analysis was based on the assumption that the left bracket is glued

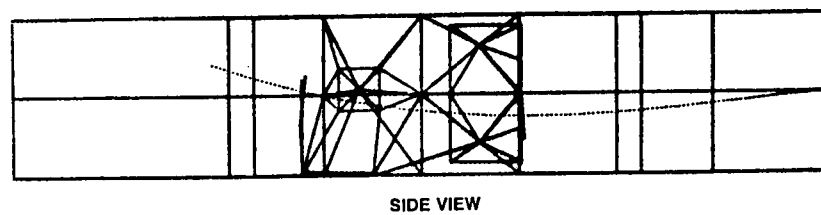
Figure 5. VCO Second Mode (Beam - Vertical at 2618 Hz)

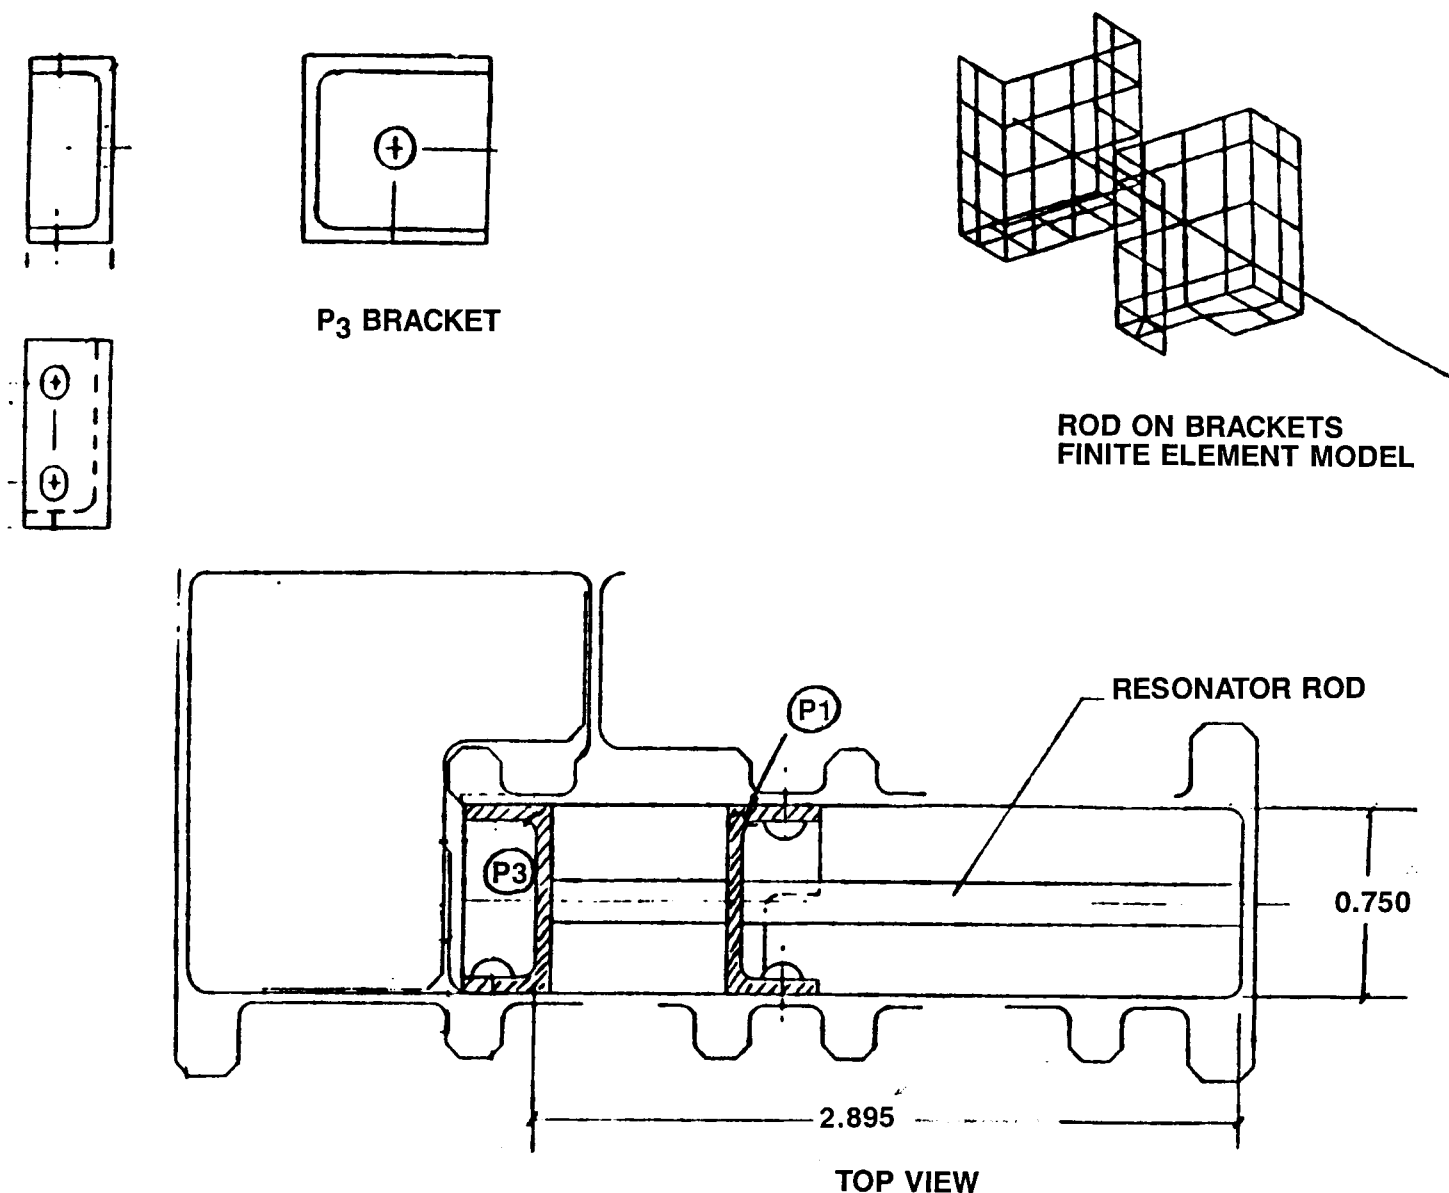
Figure 6. Redesigned VCO with New Brackets

to the bottom of the box. Inspection of the VCO hardware that had shown the sideband problem revealed that the bracket fixity was less than the perfectly glued condition. This fact coupled with the results of rod model analysis led to a redesign of the brackets shown in Figure 6. The reanalysis on the new configuration confirmed that the resonator rod modes in the frequency range of 1600 Hz and 3200 Hz have been eliminated. Figures 7 and 8 show the two lowest frequency modes for the redesigned configuration. These represent overall box modes which are not expected to cause any sideband problem.

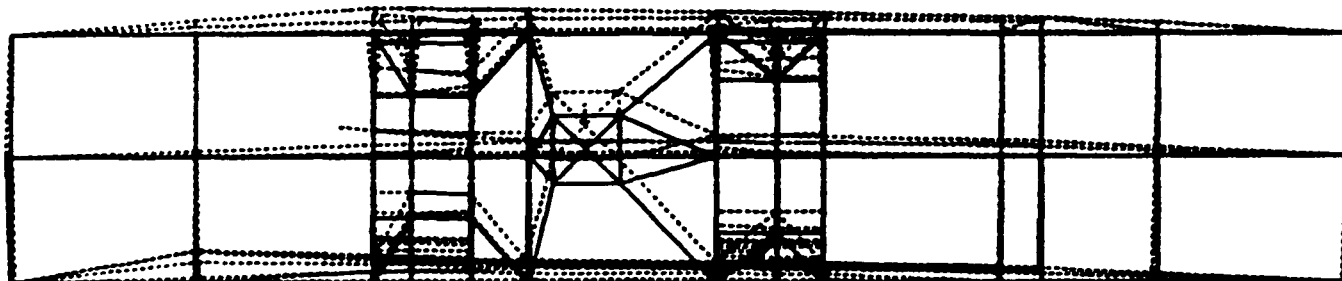
Figure 7. First Mode at 2606 Hz of Redesigned VCO

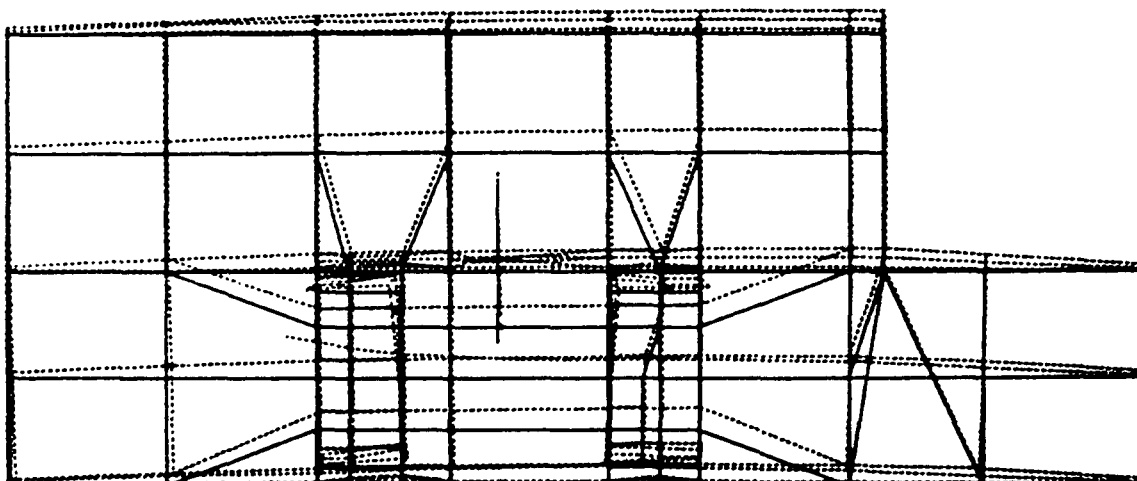
Figure 8. Second Mode at 3039 Hz of Redesigned VCO

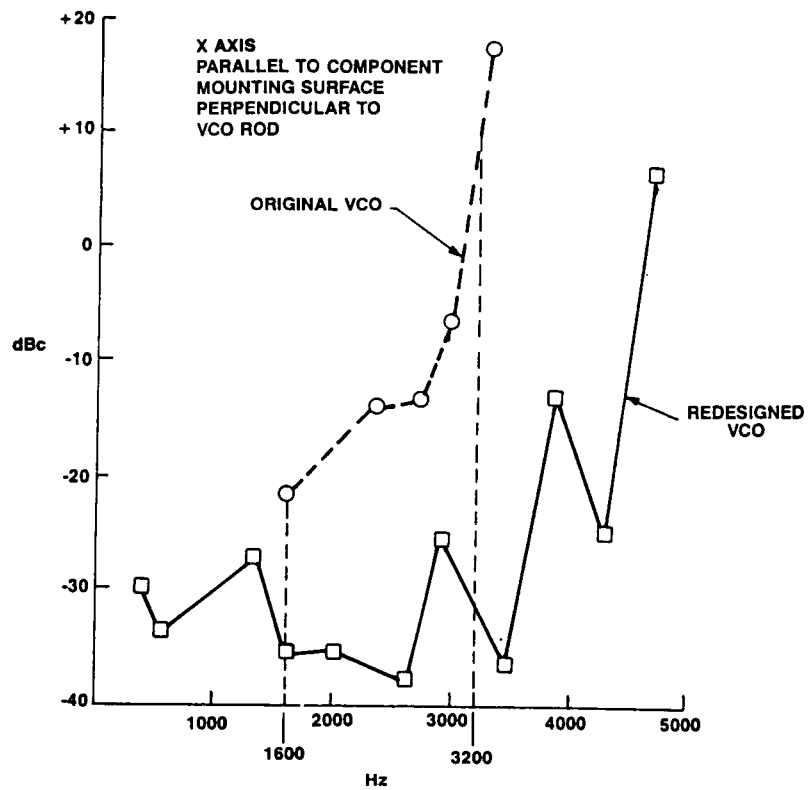
Figure 9. Component Vibration Response (Sideband to Carrier Ratio)

The VCO assembly was subjected to low level sine vibration tests to measure the sideband response. Tests were first performed with the original rexolite bracket configuration and then repeated with the resonator rod supported on the recommended brackets. Figures 9, 10 and 11 show the sideband amplitude to the carrier in the three axes as a function of frequency. The responses show significant reduction in sidebands when the recommended design change was implemented for the resonator rod support brackets. For example, in the Y-axis there was a 32 dB reduction at 1600 Hz and a 30 dB reduction at 3200 Hz. Similarly, reductions of 16 dB at 1600 Hz and 24 dB at 3200 Hz were measured in the Z-axis. Accounting for the variation in the fixity conditions between the analysis and the implemented hardware, this test provided a valuable verification of the analytical predictions and confirmed the validity of the recommended configuration.

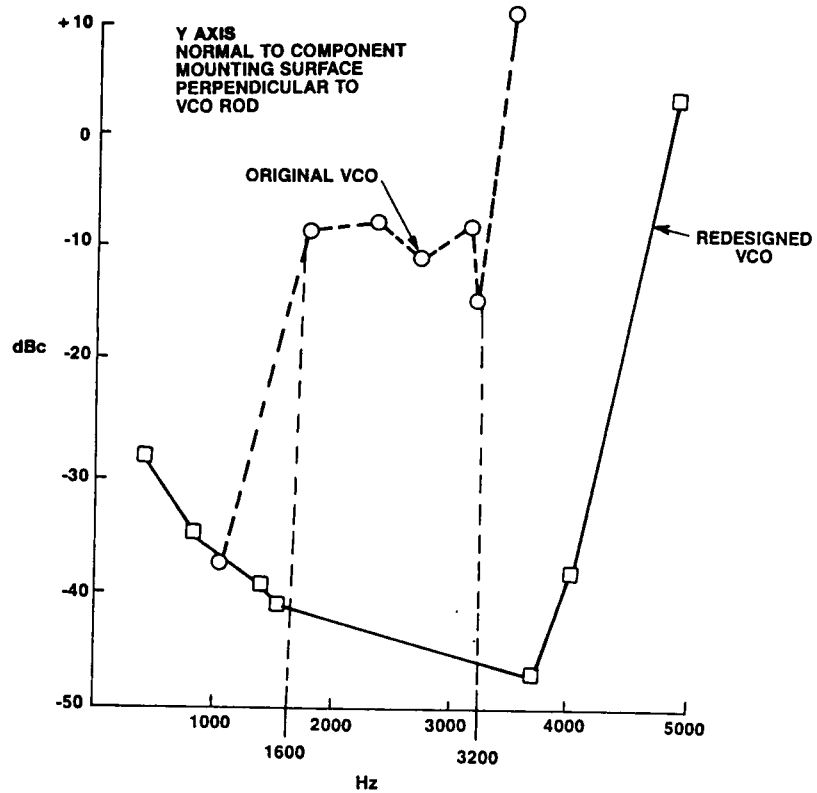
Figure 10. Component Vibration Response (Sideband to Carrier Ratio)

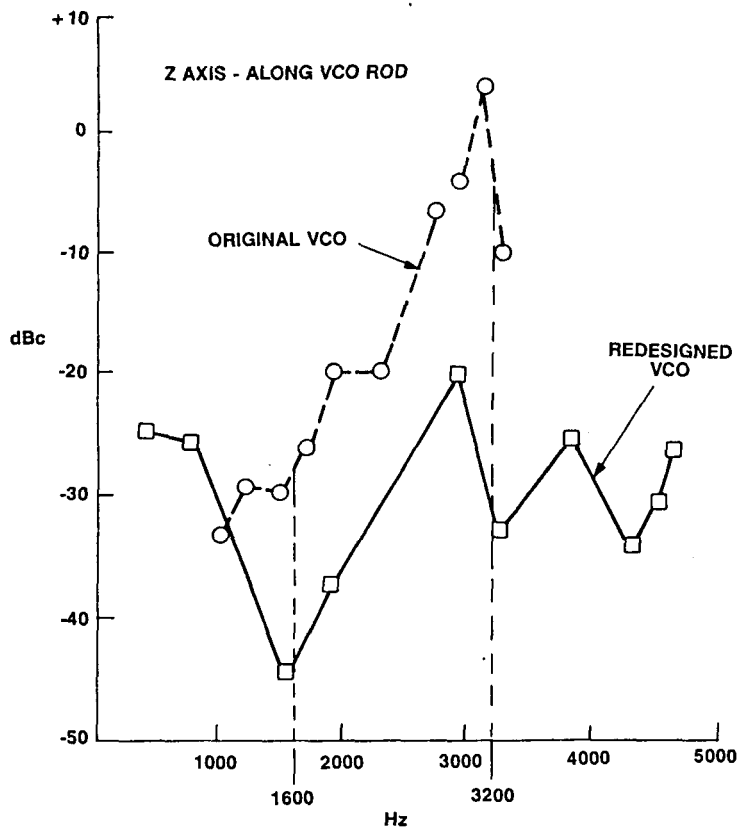
Figure 11. Component Vibration Response (Sideband to Carrier Ratio)

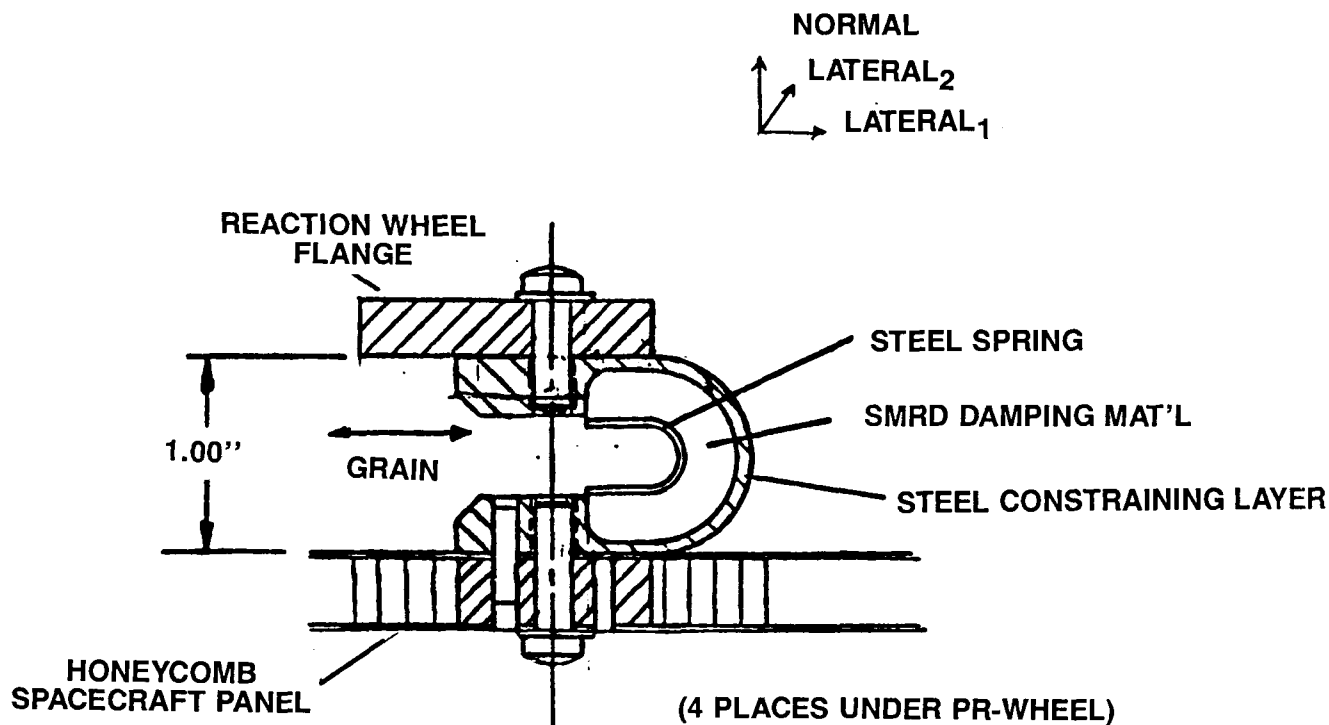
Figure 12. Isolation Mount Assembly Detail

The preliminary requirement from spacecraft control system considerations was for an isolator frequency of approximately 100 Hz so as to provide no appreciable magnification below 1 Hz. The final design of a steel spring isolator meeting this requirement is shown in Figure 12. The flexible portion of the spring is .055 inch thick stainless, .5 inches wide. The fatigue requirement of design for four lifetimes is also met by this design. The damping treatment inside the spring was .25 inch thick GE SMRD 100F90B with a .030 inch thick stainless steel

constraining layer, providing a loss factor of approximately .3 ($\xi = .15$). This high damping will minimize dynamic loads at the isolator resonance while still providing good high frequency isolation. A base shake test performed on these isolators with an Engineering Model reaction wheel showed their fundamental frequencies to be 120 Hz laterally and 130 Hz axially with a measured Q of approximately 3 in both directions.

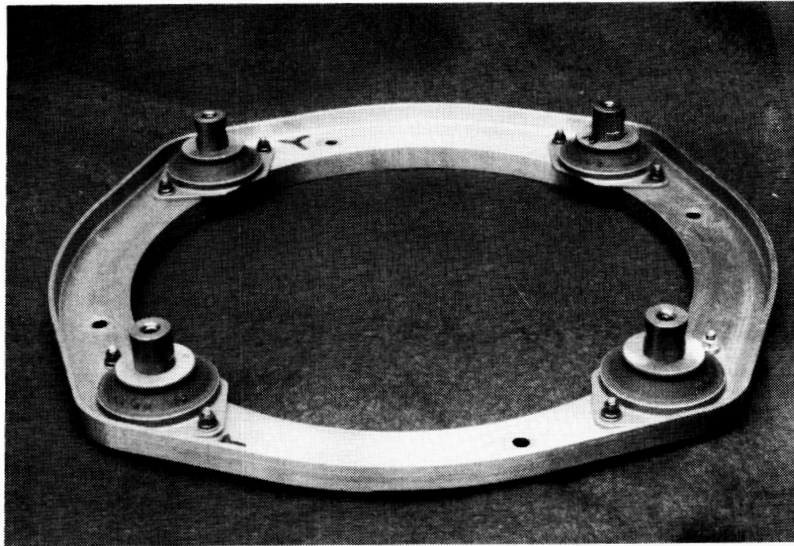
Figure 13. Silicone Isolators and Adaptor Ring

The chosen commercial silicone mounts have two attachment holes each. To avoid modification of the honeycomb structure to which the reaction wheels attach, a milled aluminum adaptor ring (Figure 13) was designed to provide an interface which would pick up the four existing mounting holes. A base shake test on these mounts showed the fundamental frequencies to be 105 Hz and 115 Hz in the lateral and axial directions respectively. Damping at resonance was adequate providing a Q of about 7.

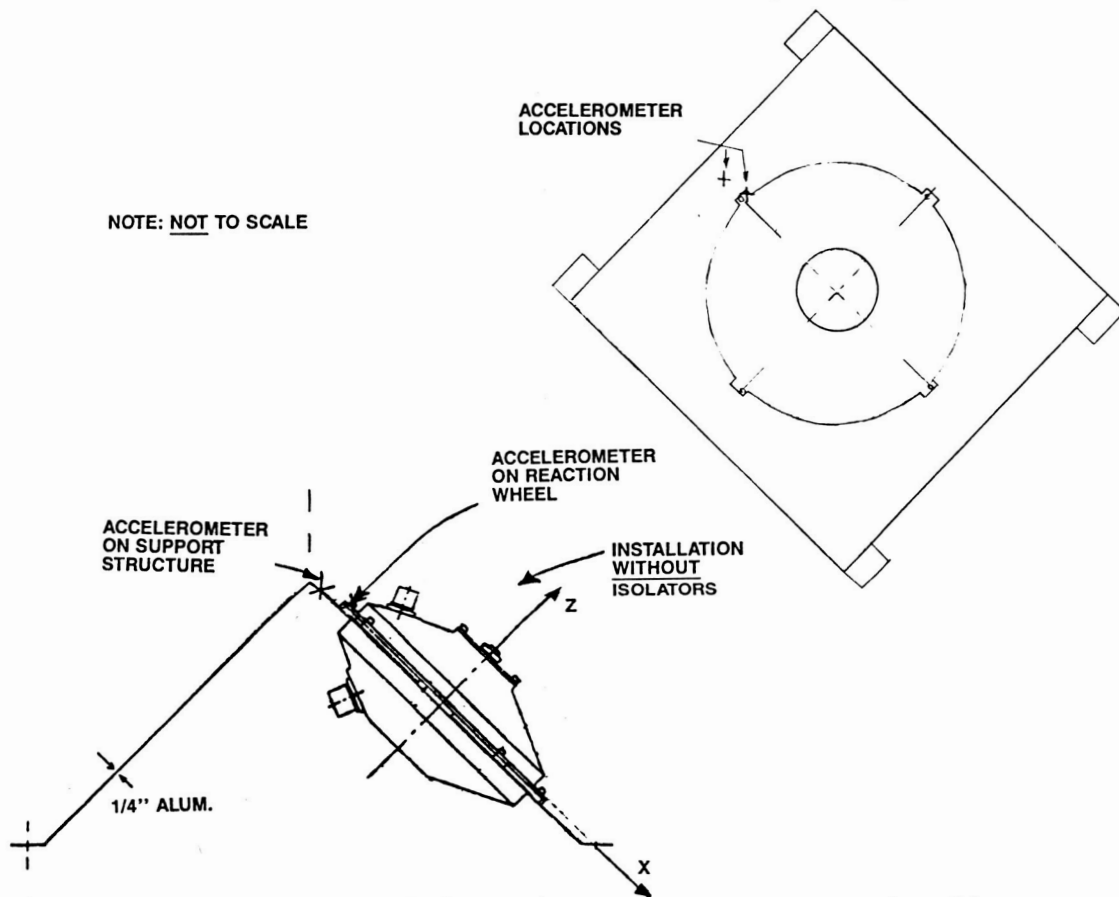
Figure 14. Reaction Wheel in Attitude Control Engineering Fixture

Both the steel spring isolators and the commercial mounts were tested mounted to a simple plate fixture which was readily available (Figure 14). With an Engineering Model Reaction Wheel providing the excitation, vibration was measured on the fixture and on the wheel mounting flange. These tests showed that the steel spring isolators did not work well on excitation normal to the plate at both 1600 Hz and 3200 Hz. Isolation was very good in the lateral directions. The silicone isolators were found to work well on 3200 Hz vibration in all three directions, but they did not provide good isolation of the 1600 Hz excitation.

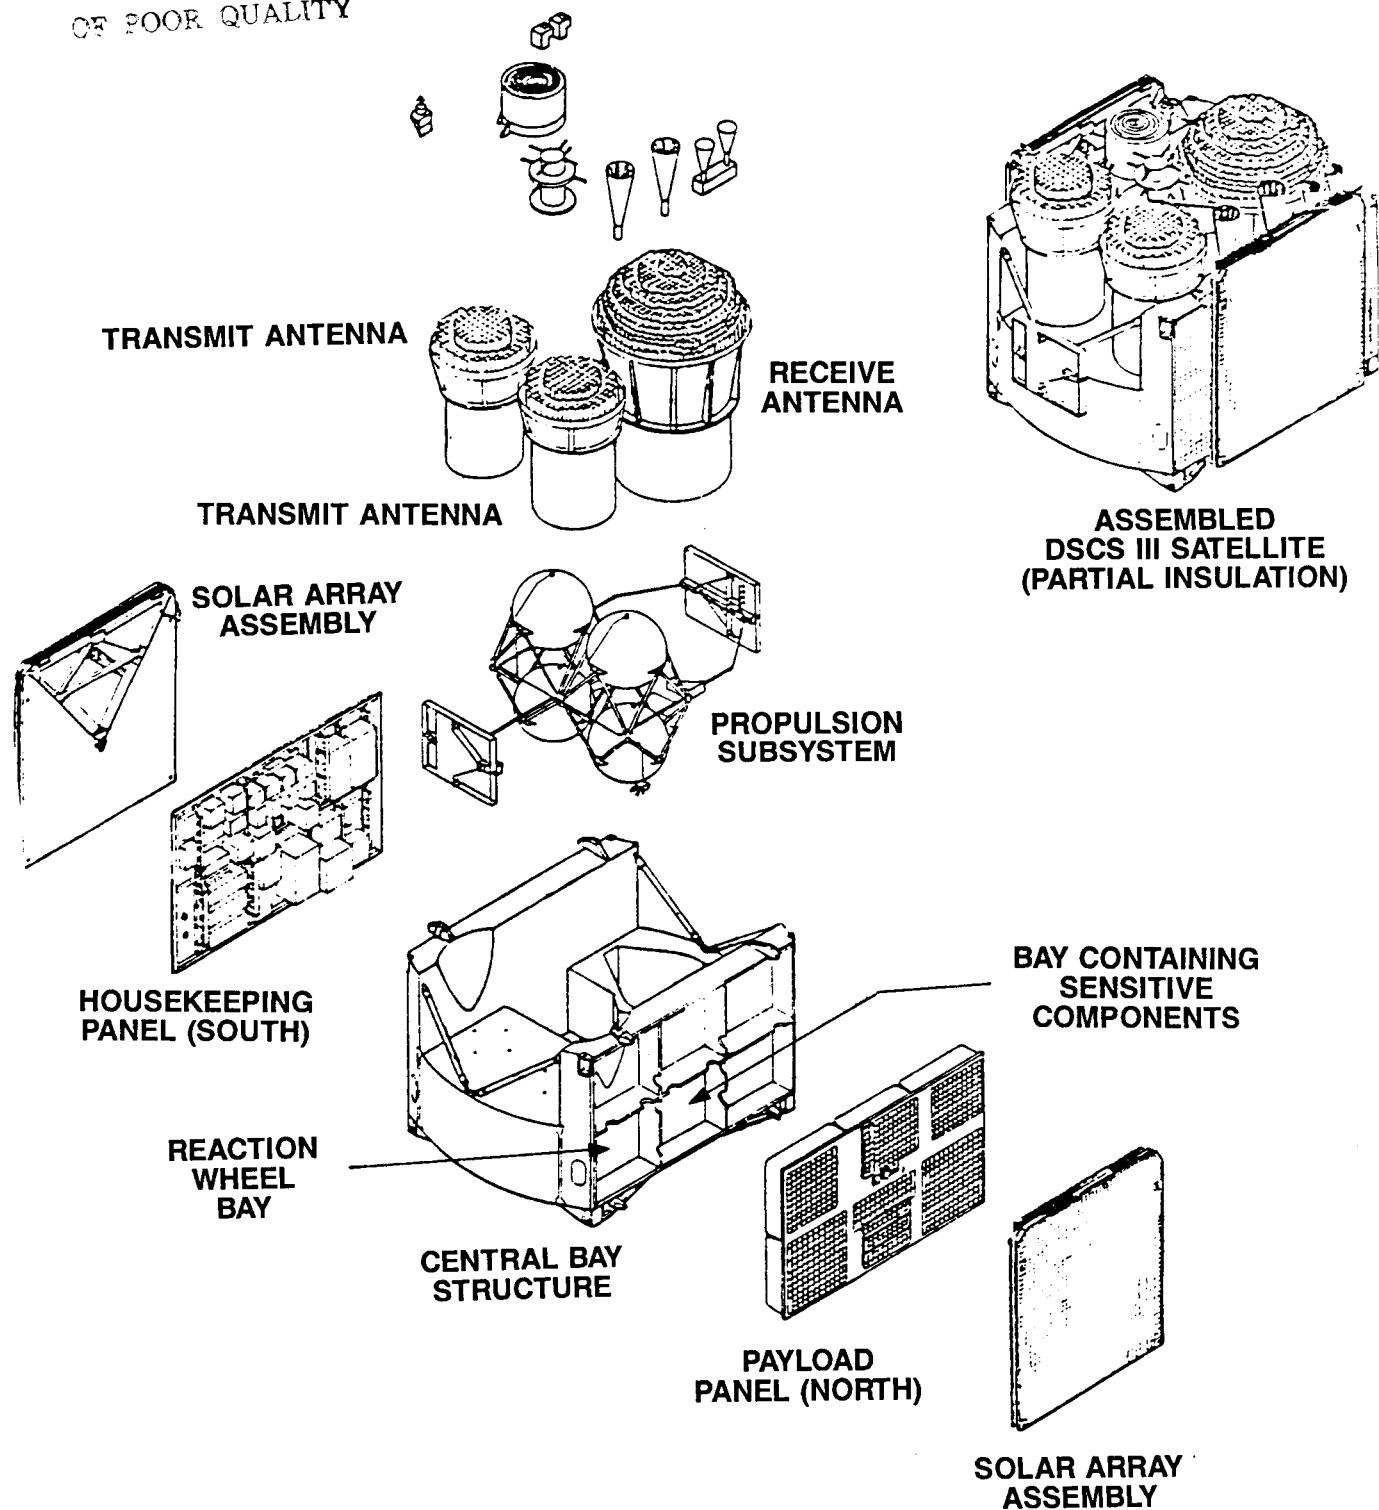
Figure 15. DSCS III Spacecraft Major Assemblies

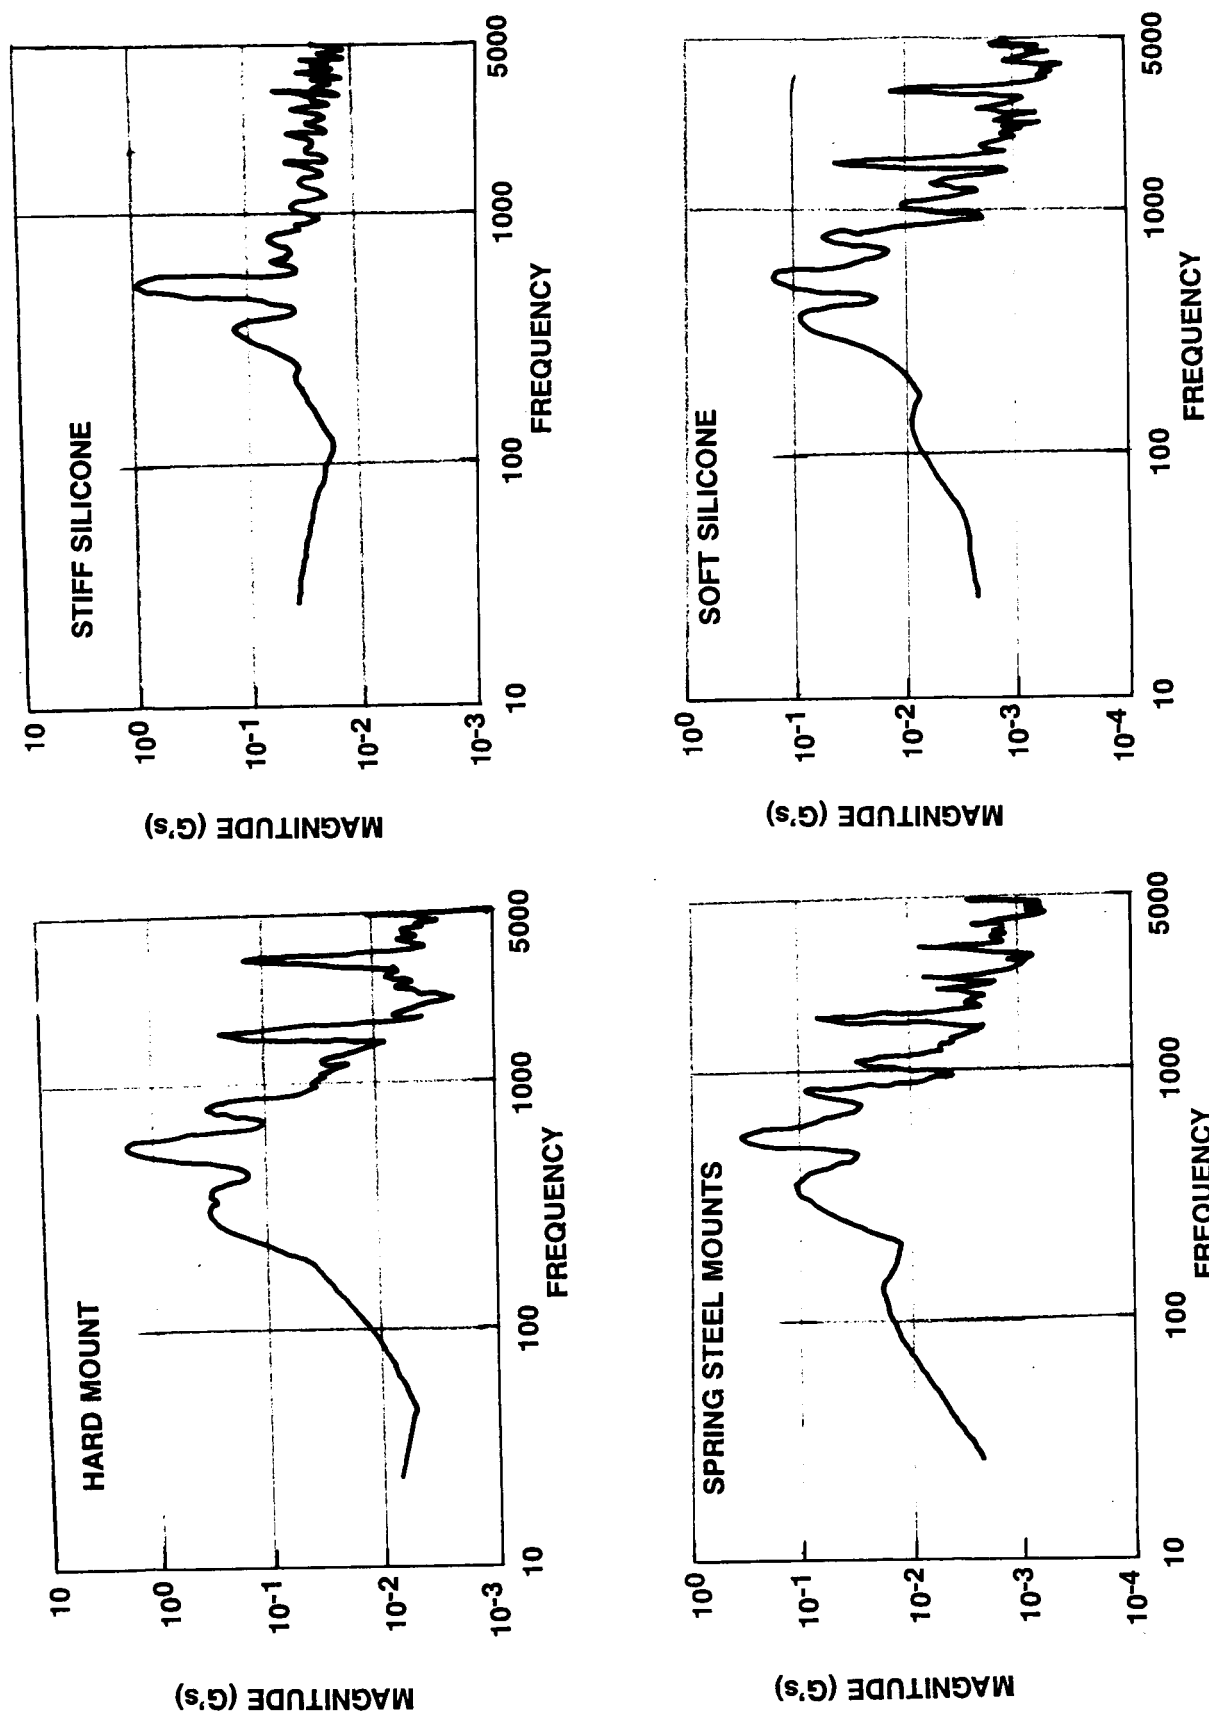
Figure 16. Centerbody Panel Response to PR - Wheel Spacecraft Axes (Fig. 3-6)

A sample from these tests is shown in Figure 16 which shows Z axis accelerometer response due to reaction wheel excitation for all four mounting conditions. Figure 17 summarizes the results of these tests in a bar graph for all three axes. The steel isolators are seen to have worked as well as the silicon mounts in two axes (X and Z) at 1600 Hz. For the Y axis the silicone mounts were clearly superior. Rather than spend additional time in cut and try to improve the Y axis performance of the steel mounts it was decided to proceed using the soft silicone isolators.

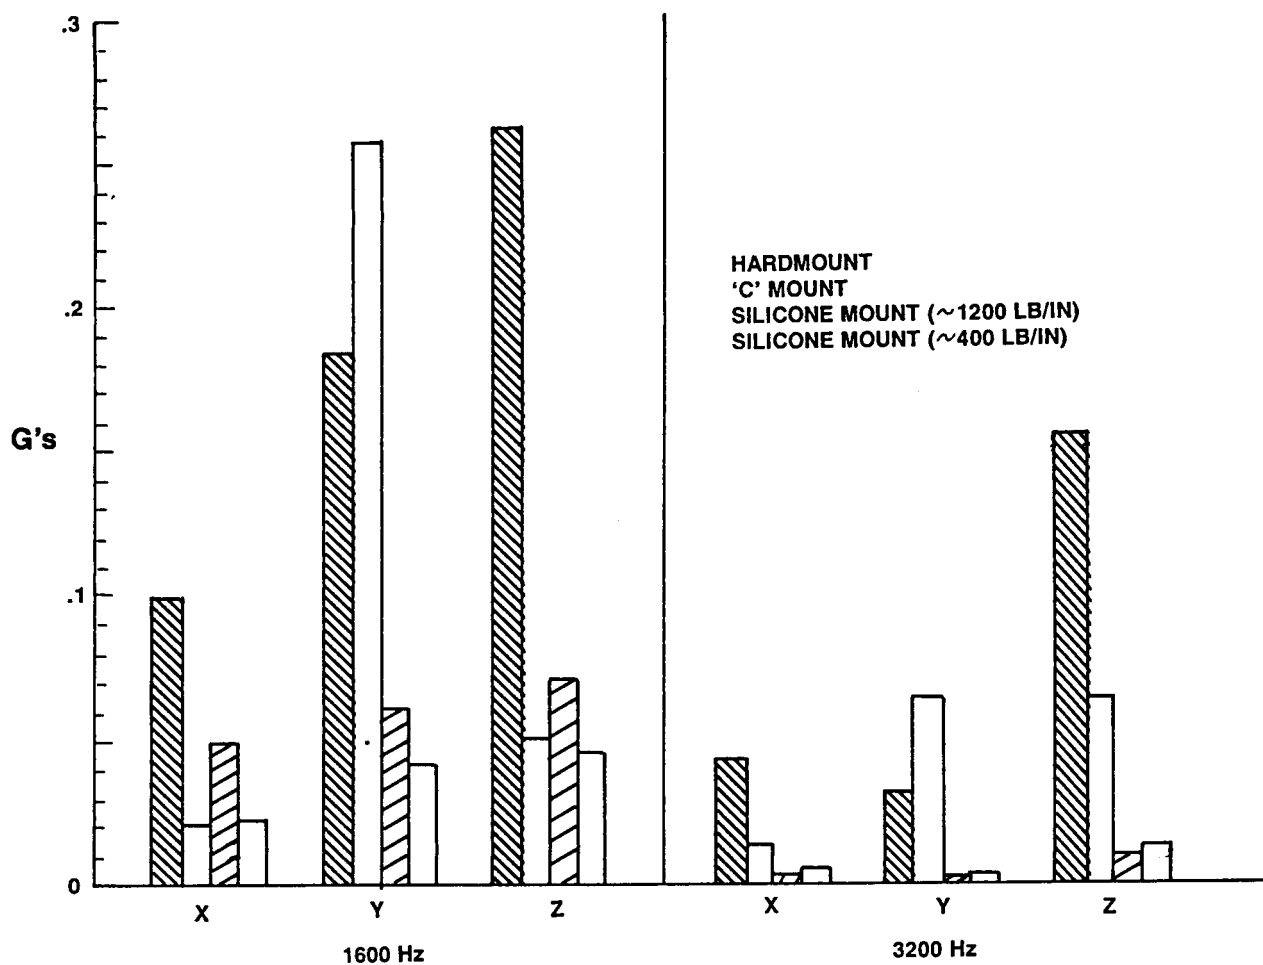
Figure 17. Test Results - Isolators on Centerbody Structure
